Confined space concrete repairs

In 2014, Edwards Diving Services (EDS) – a specialist marine, diving and confined space civil engineering contractor – was engaged by Caerphilly County Borough Council to undertake engineering repairs to 11 culvert structures located in the county borough. The need for repairs was determined following a programme of specialist confined space condition inspections undertaken in previous years. Steve Richings of EDS reports.

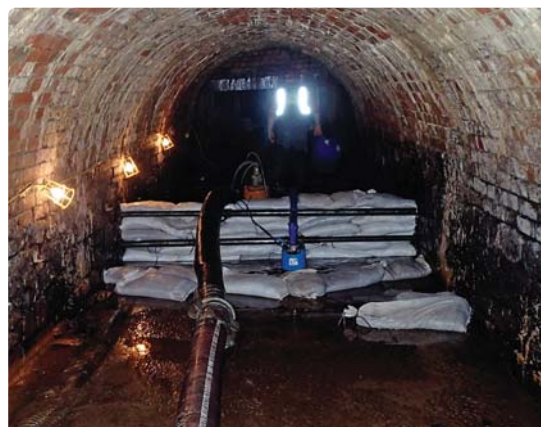
Concrete pump supply line set up in Nant Tysswg culvert.

Water management temporary works in Nant Tysswg culvert.

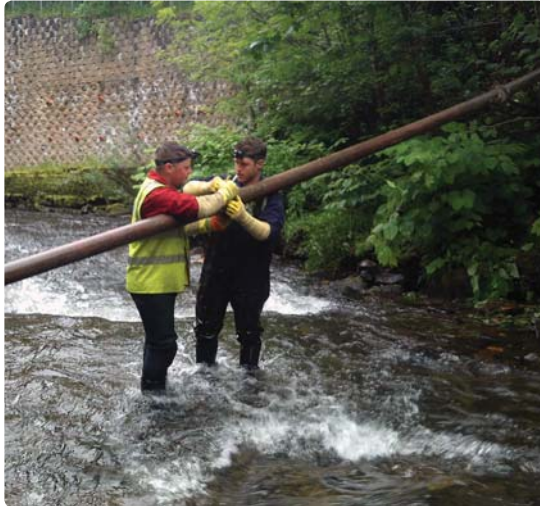
EDS engineers preparing concrete supply lines across a watercourse.

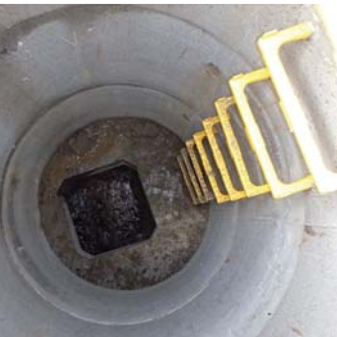
New manhole access constructed to enable concrete pump works at Nant Tysswg culvert.

EDS undertook a sond survey in order to trace the route of the culvert, identifying a set of defective soffit beams at chainage 140 as a location where a new manhole could be installed. This required construction of a widened 160m-long access track, which accessed the fishing lake, followed by opening of a 3m-deep battered excavation. A 4-tonne bespoke precast concrete slab with a centrally located access point, designed by a specialist precast supplier, CPM, was craned into place to reinstate

the culvert soffit. Precast manhole rings and cover were installed up to ground level and the area backfilled, thus access was created for the concrete pump.

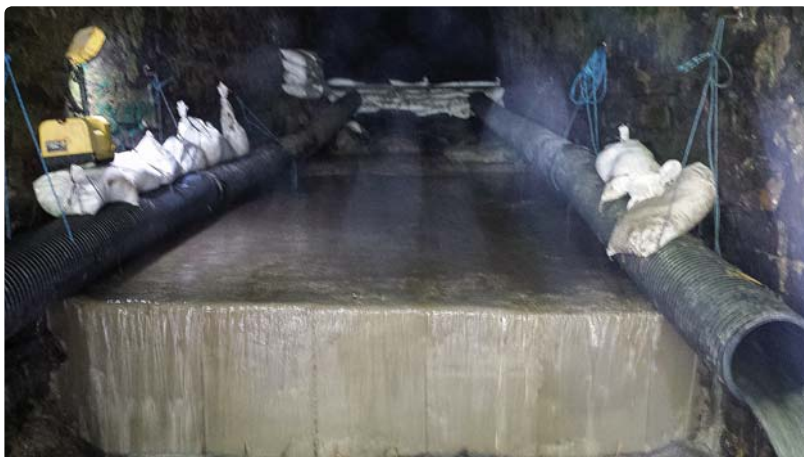
Completed concrete invert reinstatement.

Pumping operations, involving moving 34.5m³ of concrete throughout the culvert, were undertaken over a period of four separate days, with intervening days being used for relocating the temporary works between repair locations. The operations were ultimately a success, resulting in a reinstated culvert invert providing stability to the structure and protection of the load-bearing abutments from washout for years to come.

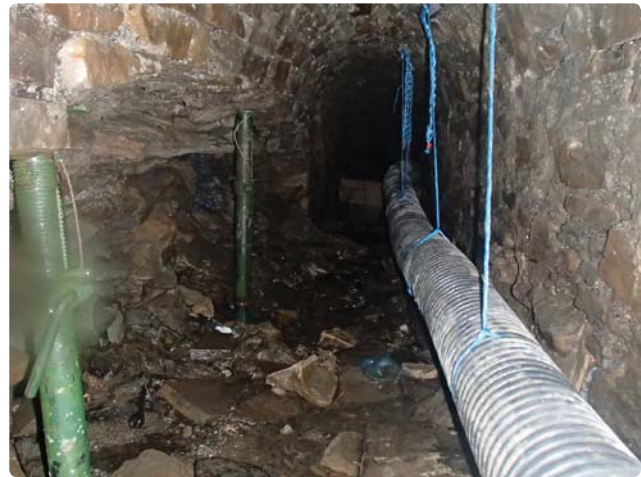
Masonry arch culvert with collapsed abutment and scoured invert, and with temporary works in place.

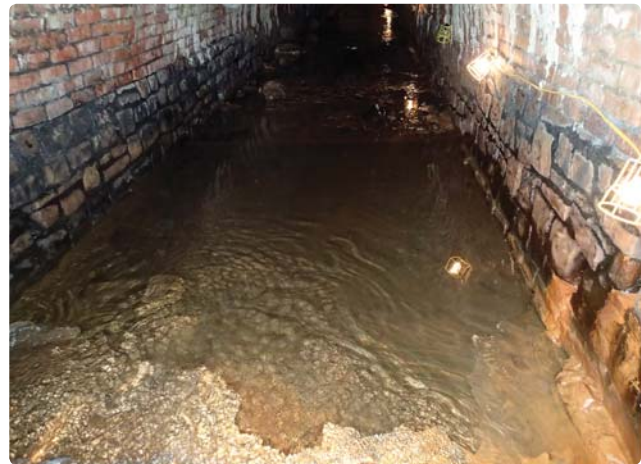
Typical scoured invert area in Nant Tysswg culvert, prior to preparing for repair.
